## SAFETY ISSUES INVESTIGATION REPORT SII A05-01

# POST-IMPACT FIRES RESULTING FROM SMALL-AIRCRAFT ACCIDENTS

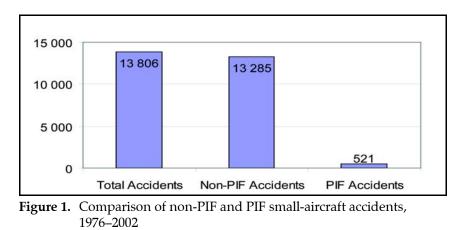
The ASIS database contains records of 13 806 small-aircraft accidents that occurred in Canada from 1976 to 2002. These accidents involved all types of privately and commercially operated aircraft, including production<sup>8</sup> and amateur-built aeroplanes, production and amateur-built helicopters, and basic and advanced ultralights. As a follow-up to the A00W0109 investigation, the TSB determined that PIF had occurred in 521, or 3.8 per cent, of these accidents.

The 13 806 accidents had resulted in 3311 fatalities and 2217 serious injuries. The 521 PIF accidents had accounted for 728 fatalities, or 22 per cent of all fatalities, and 231 serious injuries, or 10.4 per cent of all serious injuries. Compared to the fatality rate for all accidents, the fatality rate for PIF accidents was 5½ times greater, and the rate for serious injuries was nearly triple.

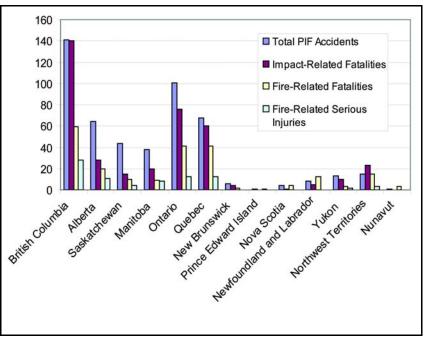
Figure 2. Geographic distribution of PIF accidents and injuries

The number of PIF accidents varied appreciably among provinces, with British Columbia accounting for approximately 27 per cent of the total. Two factors that appear to influence the number of PIFs in a specific region are the accident rate in that region and the terrain. British Columbia's mountainous terrain contributes to a higher accident rate for small aircraft, due to the increased operational risks that are associated with low-altitude visual flight rules (VFR) flight in mountains. Accidents that occur in mountainous terrain appear to result in a higher incidence of PIF, as well as a higher incidence of impact-related fatalities, regardless of whether PIF occurs. This is likely due to the increased severity of impacts in rough terrain.

The ratios of impact-related injuries to fire-related injuries also varied among provinces, with British Columbia, Yukon, and western Northwest Territories having greater proportions of impact-related injuries in PIF accidents, compared to less mountainous provinces. Factors that may have influenced the ratios of impact injuries to fire injuries are variations in accident dynamics, differences in post-mortem examination protocol among provinces, or varying levels of TSB communication with different coroner and medical examiner jurisdictions.

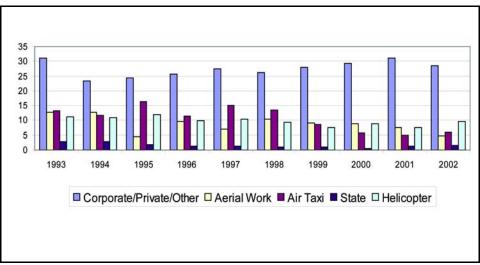
Figure 3. Canadian accident rates per 100 000 hours by operator type, 1993–2002

The TSB publishes 10-year accident rate statistics for Canadian aircraft operations. The accident rate trends for air taxi operations have shown a significant downward trend, from 13.2 accidents per 100 000 hours in 1993 to 6.0 accidents per 100 000 hours in 2002. The accident rate for aerial work has also decreased markedly, from 12.7 accidents per 100 000 hours in 1993 to 4.6 accidents per 100 000 hours in 2002. The rates for state and helicopter operations have remained relatively stable during that time. While the accident rate for corporate/private/other has fluctuated, overall, it was down from 31.2 accidents per 100 000 hours in 1993 to 28.4 accidents per 100 000 hours in 2002. While the accident rates for these primarily small-aircraft operations have declined generally, they remain significantly higher than the accident rates for commuter and airline operations that use aircraft weighing more than 5700 kg.

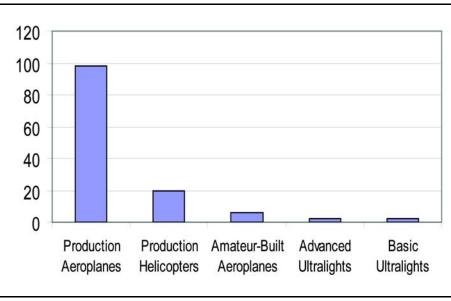
**Figure 4.** Number of aircraft involved in accidents with fire-related injuries or fatalities classified by eligibility for registration

The data subset containing 128 accidents with fire-related injuries or fatalities included 98 production aeroplanes, 20 production helicopters, 6 amateur-built aeroplanes, 2 basic ultralights and 2 advanced ultralights.

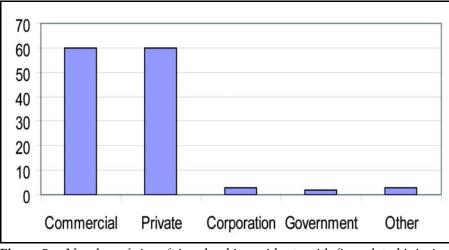
**Figure 5.** Number of aircraft involved in accidents with fire-related injuries or fatalities by type of registration

Sixty of the aircraft were being operated commercially, 60 were being operated privately, 3 were being operated by a corporation, 2 were being operated by a government agency, and 3 were involved in other operations.
